# Manhole Inspection Summary

Manhole # S04AA2025MH

**Location** Address: **6708 PARK HEIGHTS AVE**

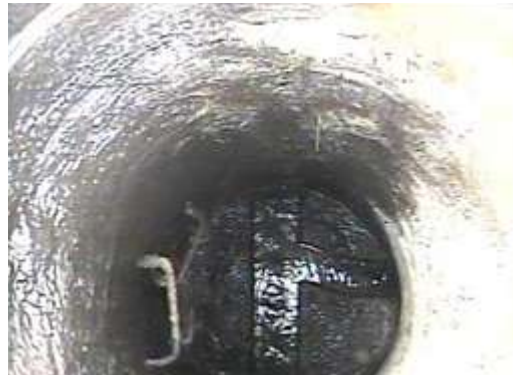
Top View

Corroded steps. Evidence of surcharge - Bench debris.

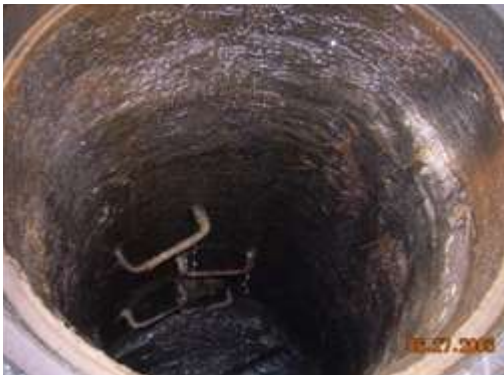
Defect

Frame leaks. Adjustment and Corbel root intrusion and infiltration.

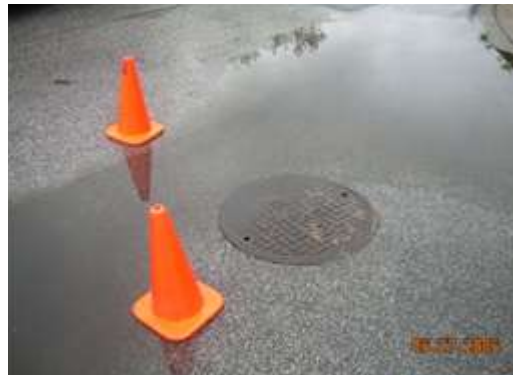
Defect

Subject to ponding.
